DIEZ AÑOS
DE INGENIERÍA
ESTRUCTURAL

TEN YEARS OF
STRUCTURAL
ENGINEERING

Puente atirantado sobre el río Henares en Guadalajara. Cable-stayed bridge over the River Henares in Guadalajara

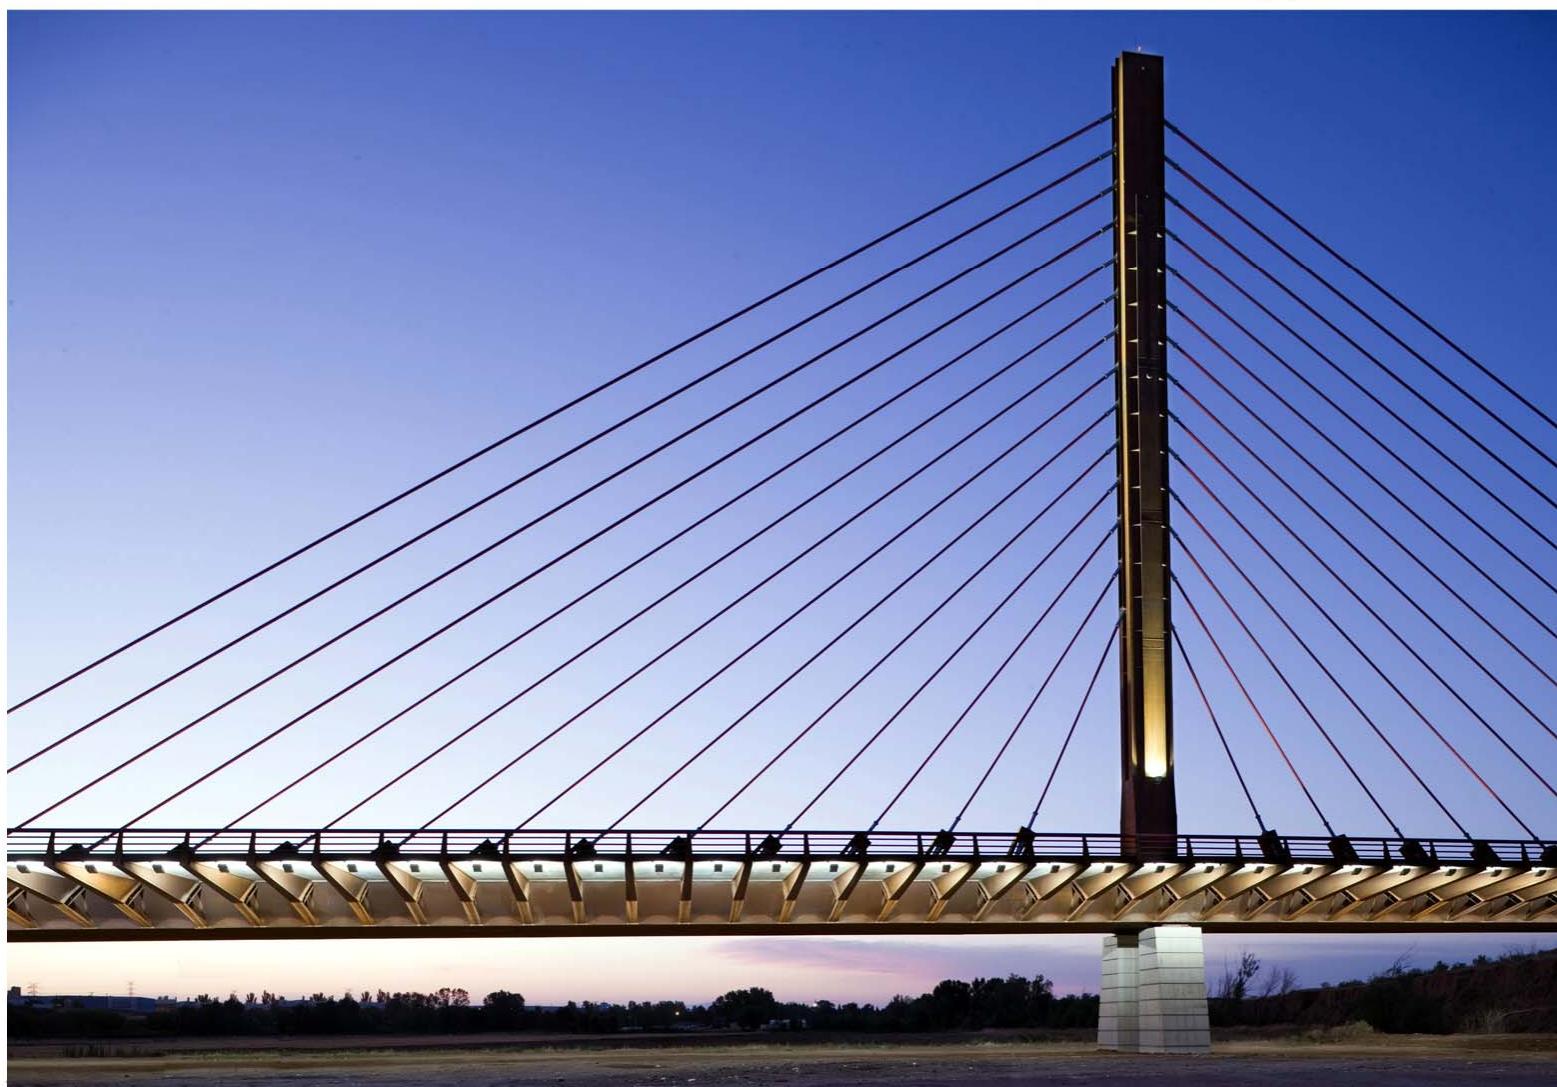
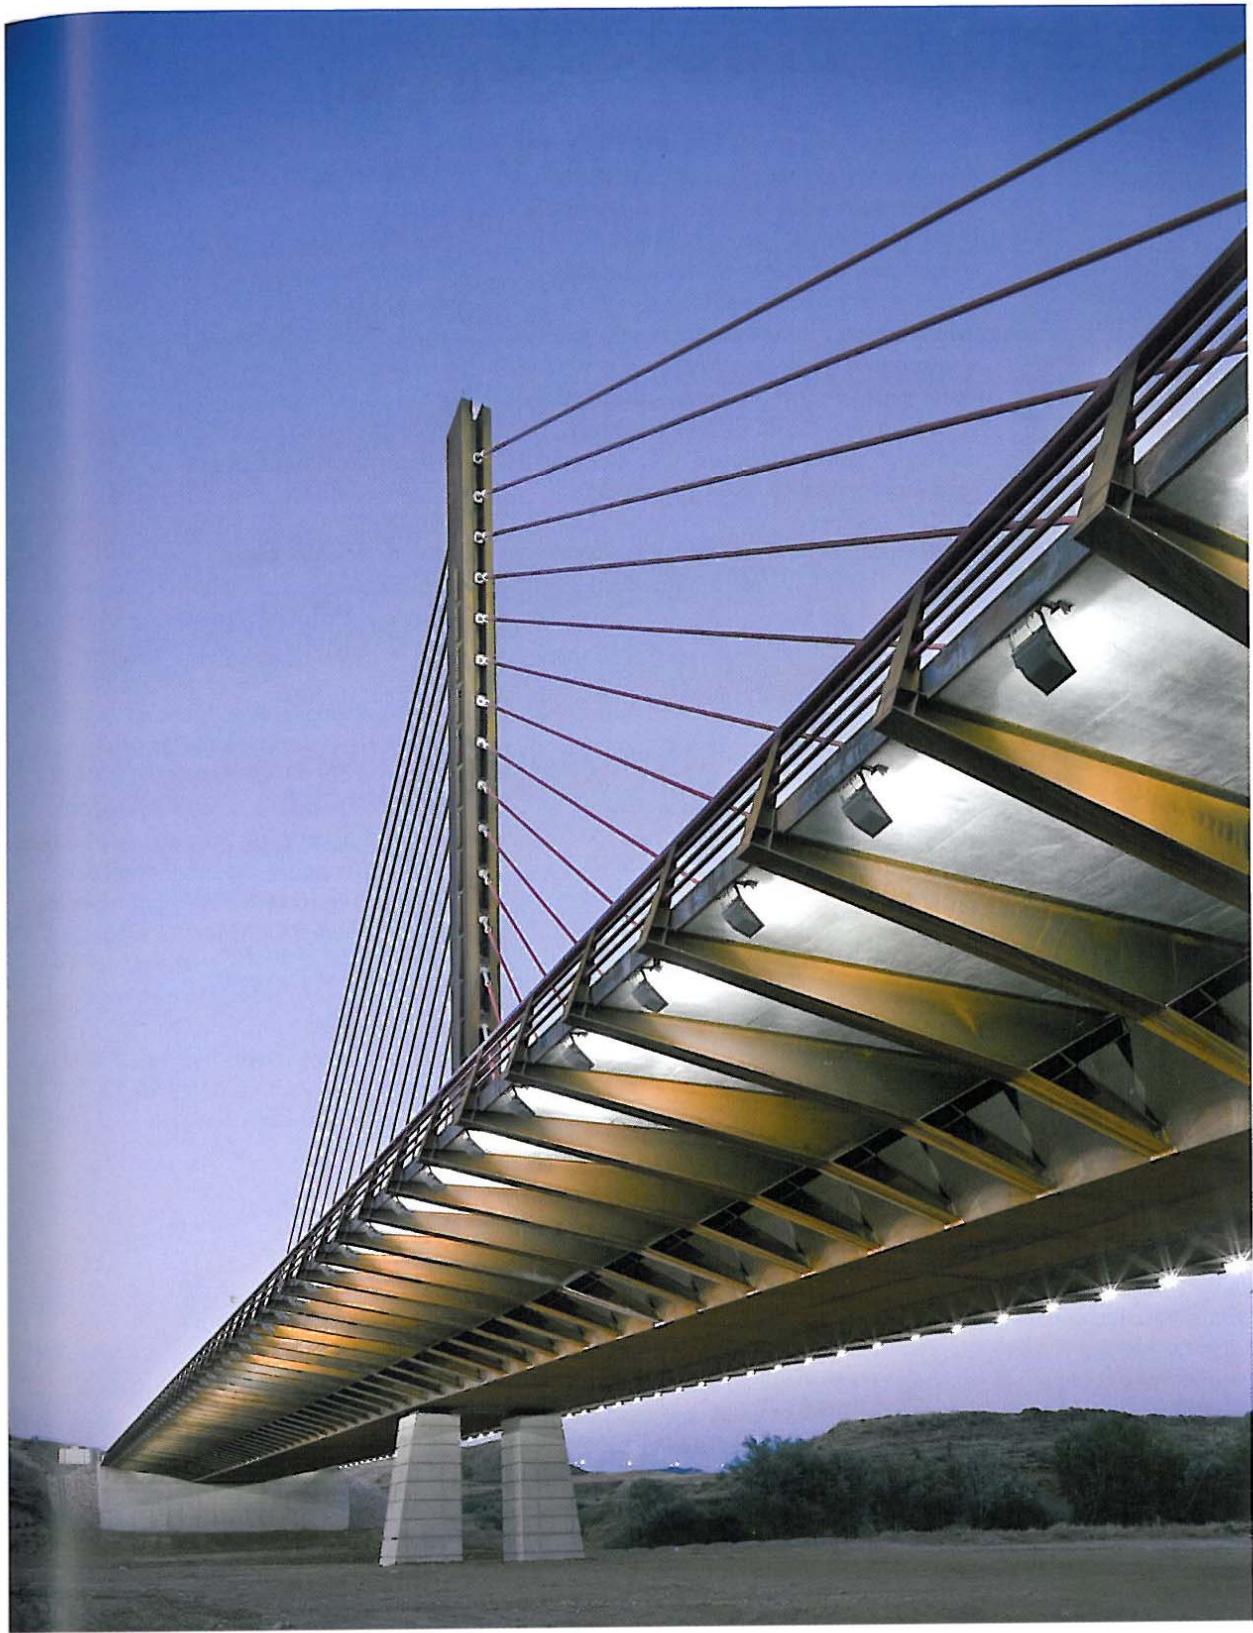
El puente tiene una longitud total de 201 m, distribuidos en un vano principal atirantado de 100,50 m y dos vanos laterales de 42 y 58,50 m. La anchura del tablero es de 30 m.

The bridge has a total length of 201 m, which were distributed along a 100,50 m main cable-stayed span and two side spans of 42 m and 58,50 m, respectively. The deck is 30 m wide.

The cable stay system consists of 28 semifan-shaped cable stays distributed on a single plane. 14 of the cable stays were placed along the main span, while the remaining 14 were placed on the retaining spans.

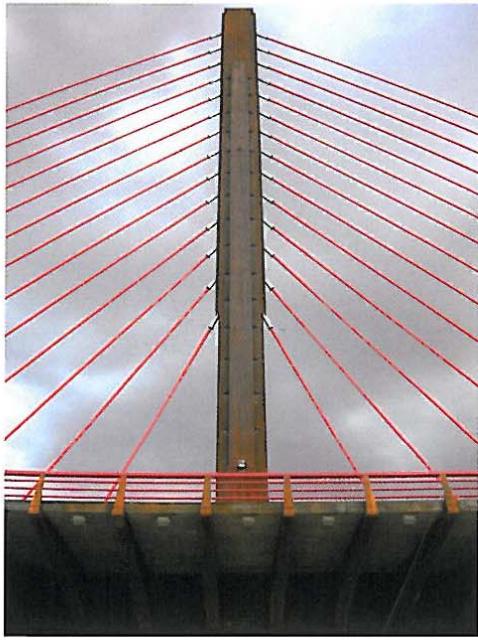
El pilono, de 58 m de altura medidos desde la cara superior del tablero, es metálico en su totalidad. Se resuelve formalmente con una H en sentido longitudinal del puente, maclada con una doble T en sentido transversal. Cada tirante del vano principal que se ancla en el pilono tiene su simétrico en el vano de rete-

The pylon, which is 58 m high measured from the upper face of the deck, was completely made of metal. Its formal structure is H-shaped in the longitudinal direction of the bridge, twinned with a double T placed crossways. Each main span cable stay that is anchored to the pylon has a symmetrical
